Investigating Fall Fatalities: Lessons Learned and Tools for Prevention

Hispanic Worker Falls From Residential Roof in North Carolina

Gutter Installer Dies After Falling From Roof

Mast Climbing Work Platform Daily Inspection Walkthrough Tool

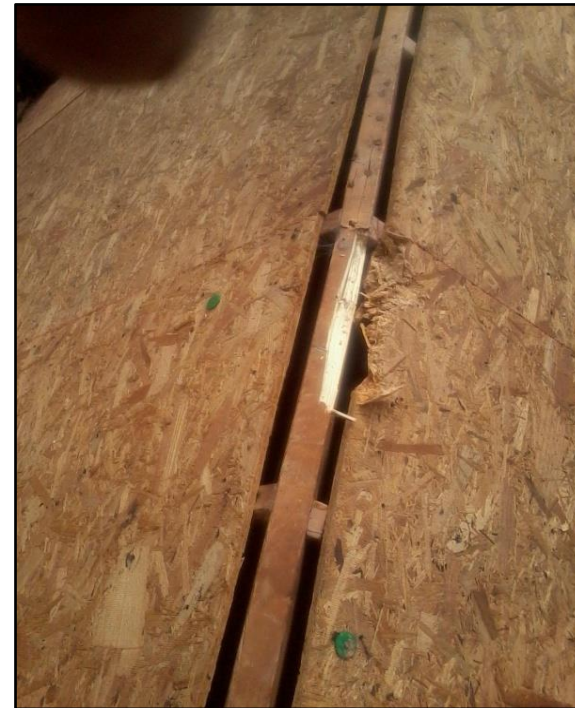
Investigation

- *13-foot plus fall distance and concrete surface*
- *10/12 roof pitch*
- *25 foot working length of fall arrest system lifeline*
- *Fall arrest system lanyard connection point*
- *Fall arrest system anchorage method*
- *Worker level of experience / lack of training*

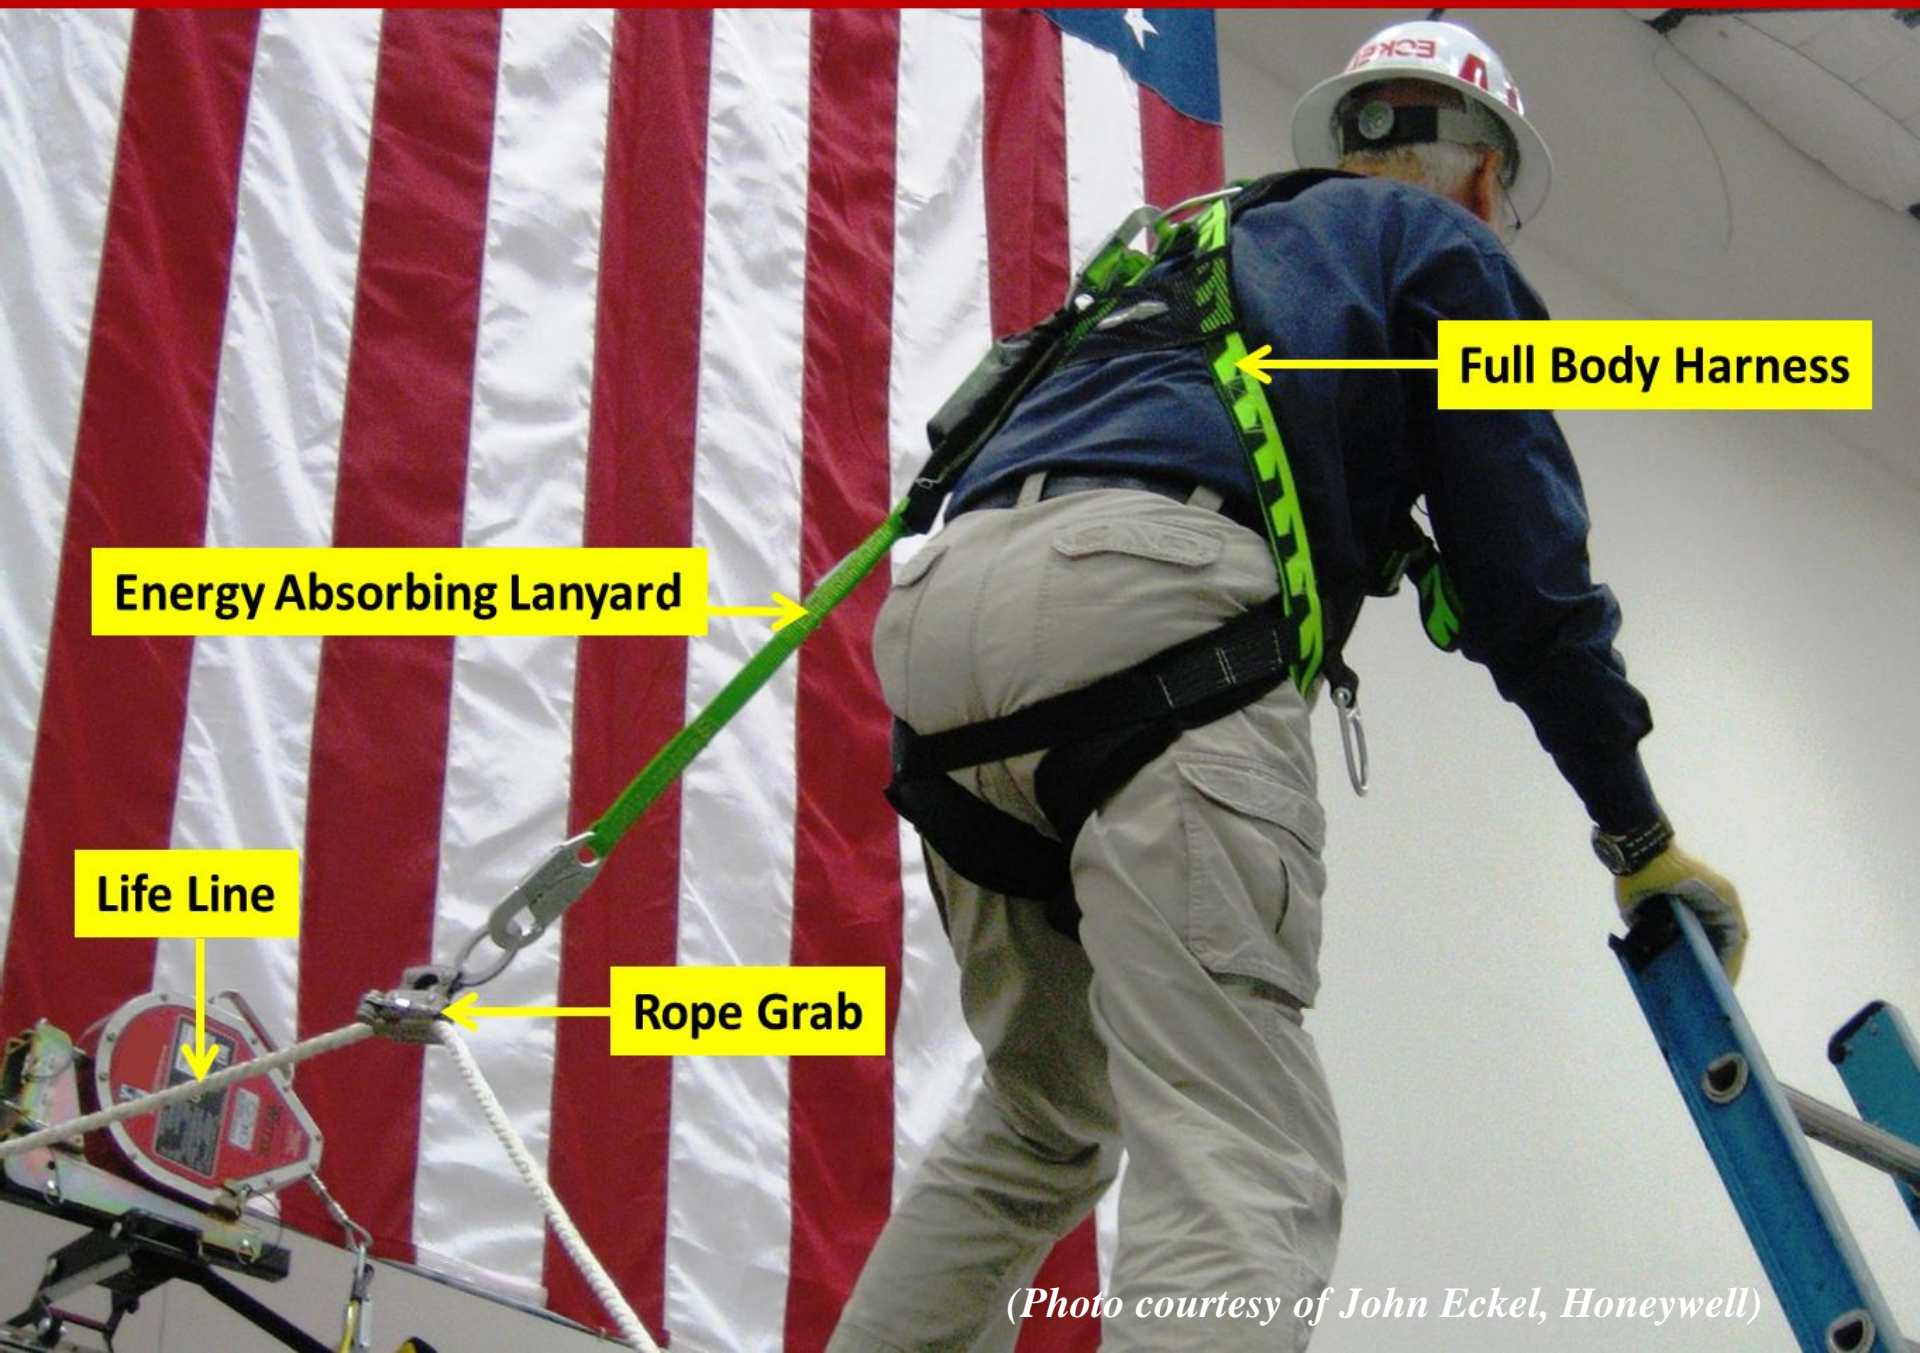
Personal Fall Arrest System (PFAS) Components

Full Body Harness

Energy Absorbing Lanyard

Life Line

Rope Grab

Recommendation #3: Employers should ensure that all employees are provided with properly assembled and maintained fall protection systems when exposed to fall hazards.

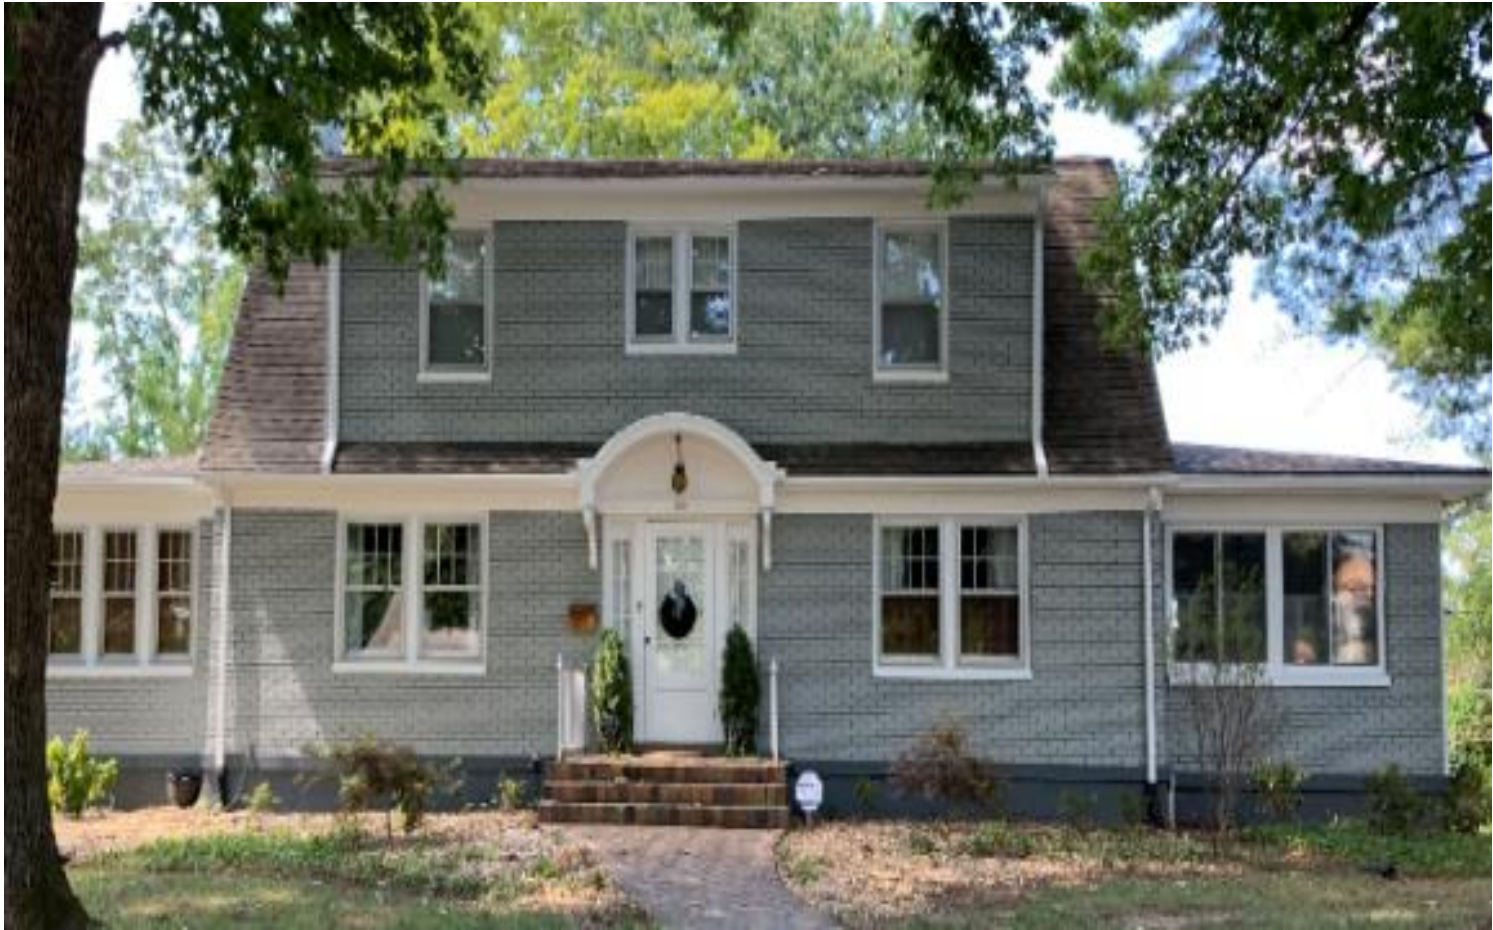
- At 9:00 AM, the victim arrived on the site of a two-story private residence to install guards on existing gutters.
- The 5,000 sq. ft. home was constructed in 1920 on a 0.61-acre lot. While most of the house was two stories, each wing of the house was one story, measuring 10 feet from the ground.
- The second story roof – from which the victim was working – measured an additional 8’3” above the first story roof.

Front view of the residence

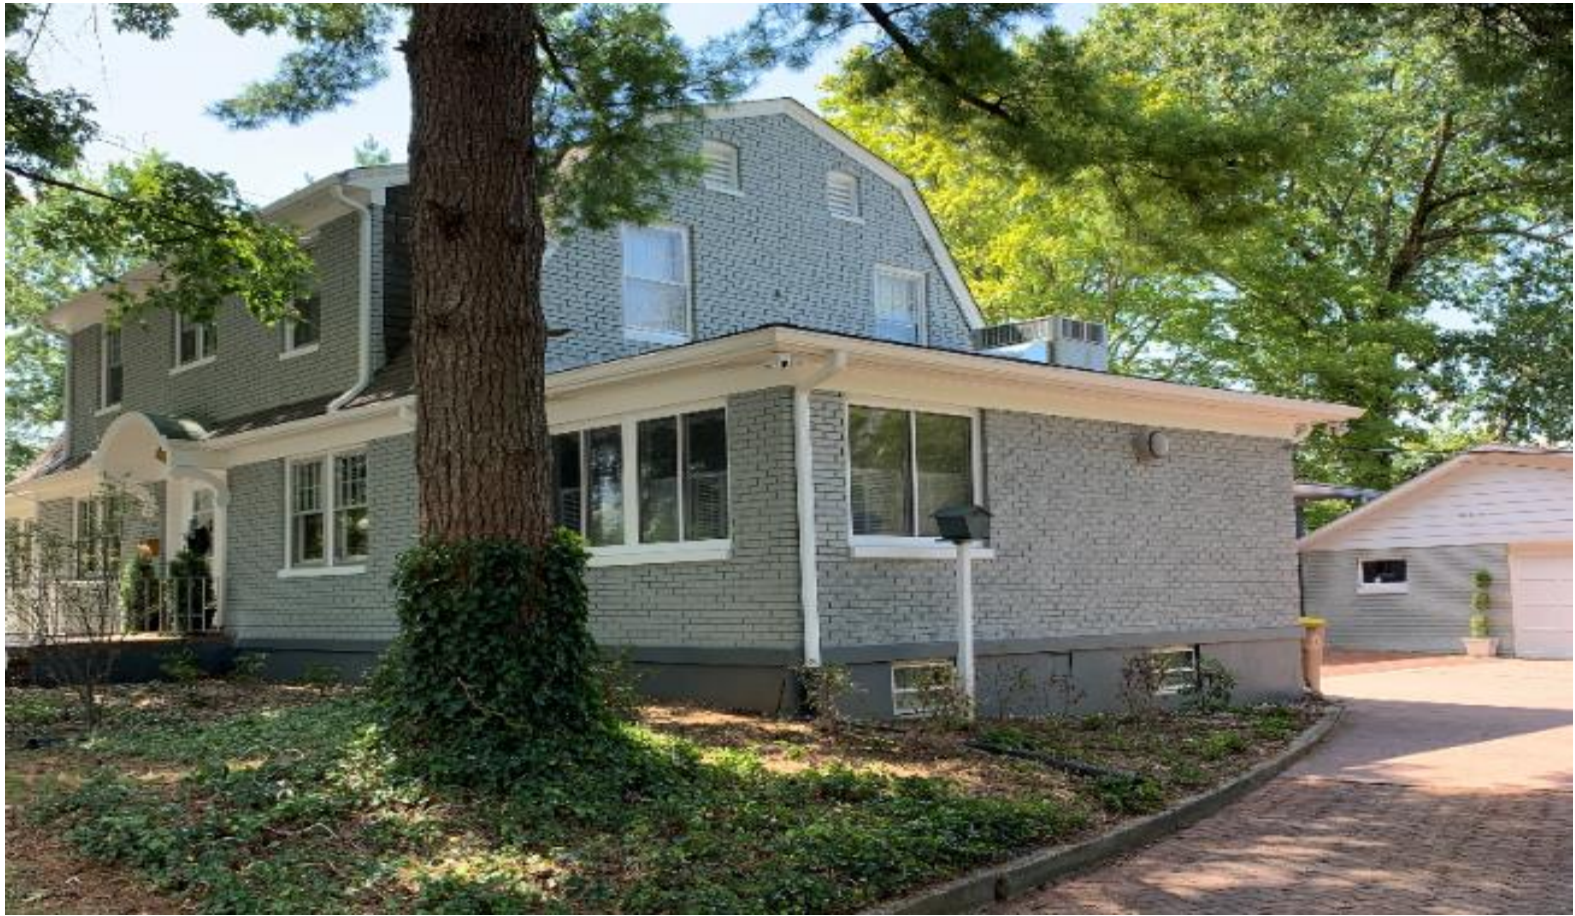
Side view of the residence

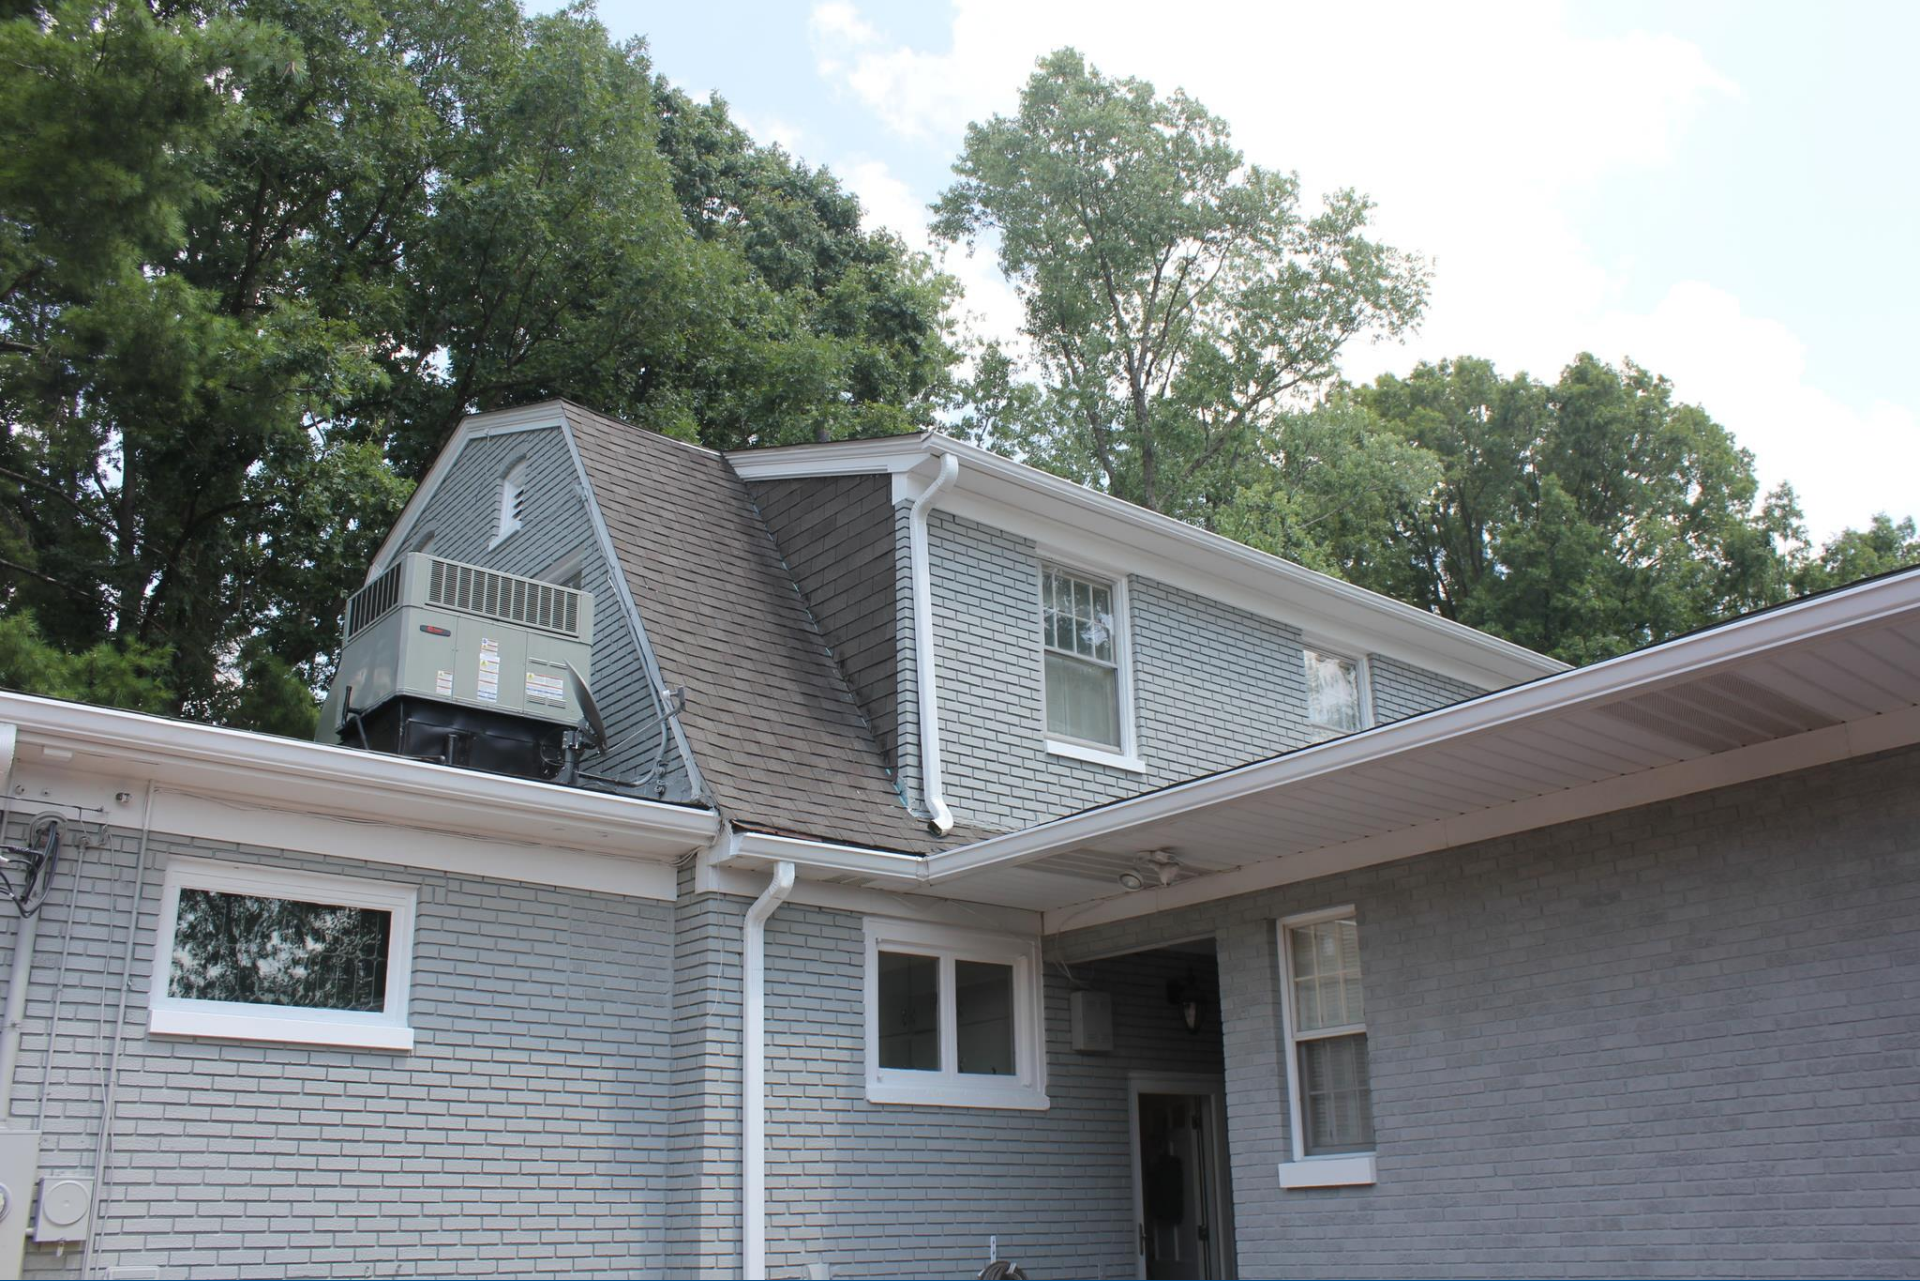
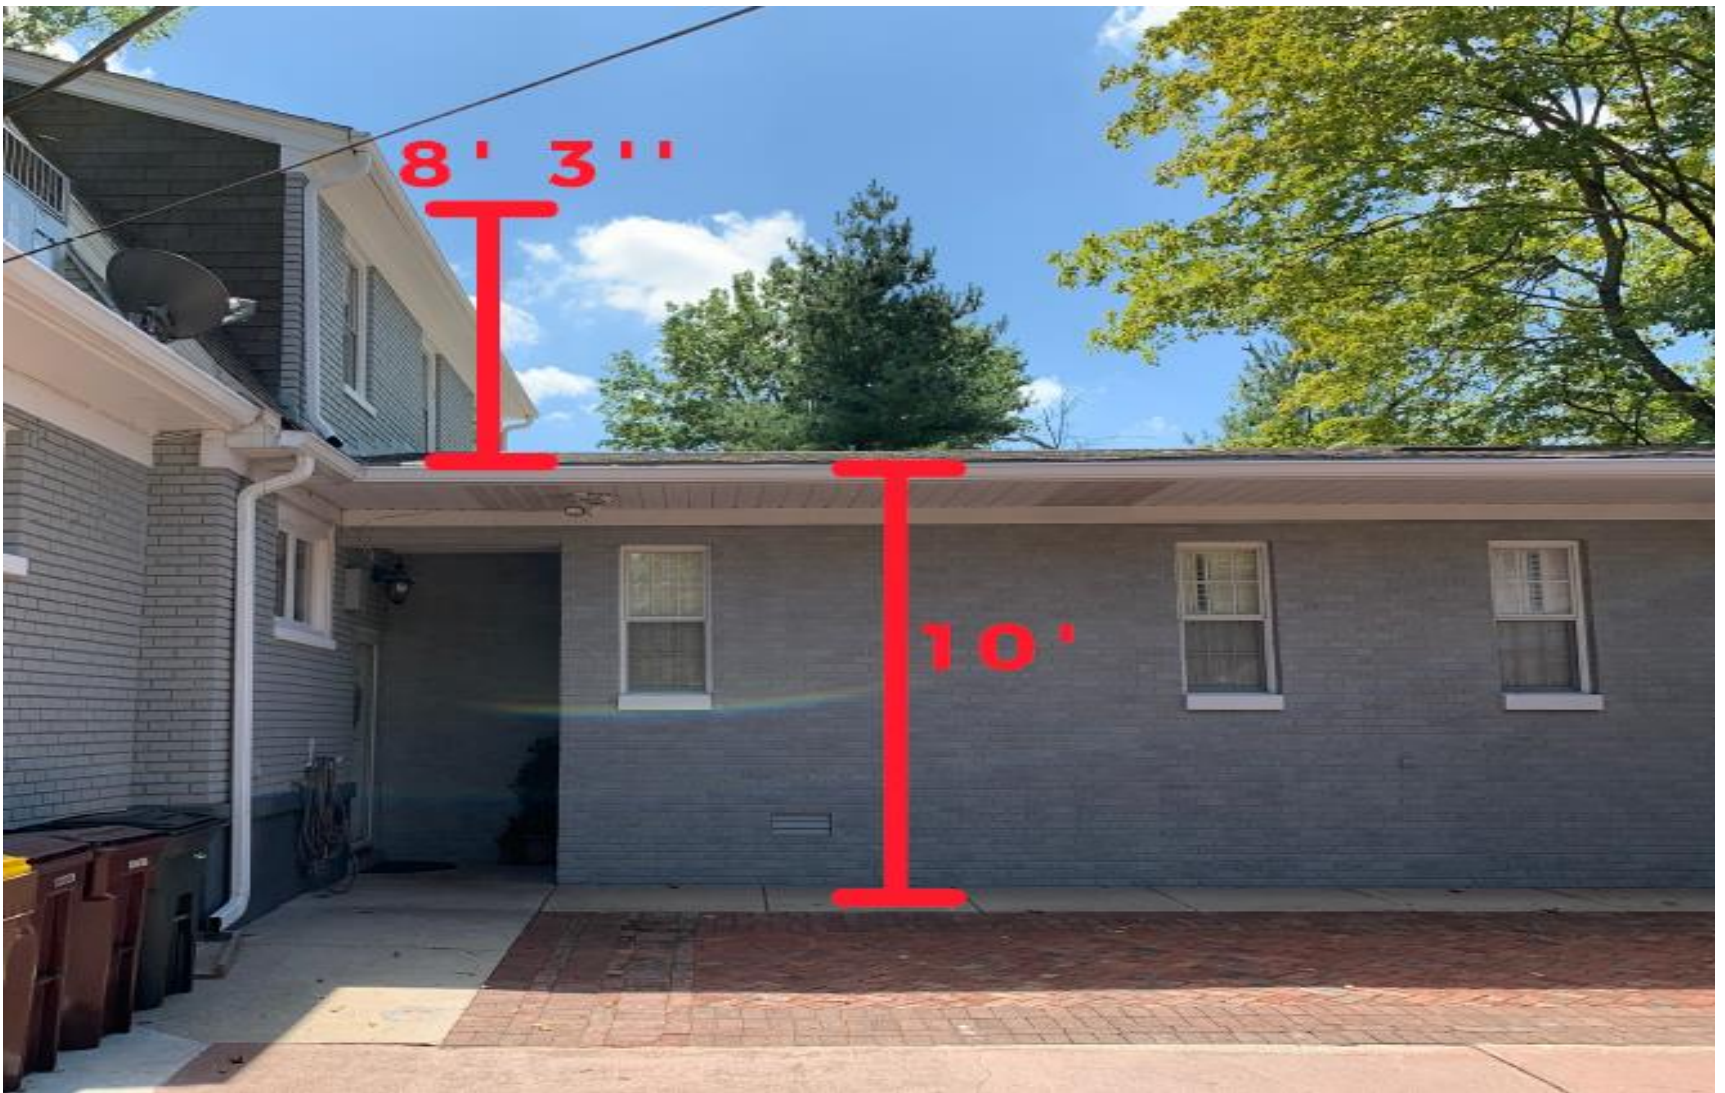
- The owner stated that as he was leaving, at 10:51 AM, he saw the victim sitting with his legs folded, leaning towards the gutter.
- Within 30 seconds of leaving, the owner was flagged down by the girlfriend, stating she had witnessed the victim fall from the second story, strike the first-floor roof.
- When they returned to check on him, the victim had fallen to the concrete driveway.

Area from which the victim fell

- There was no training on or use of fall protection.
- No hazard analysis was performed.
- The victim was working at heights with a known medical condition.

- Employers should train employees on and enforce the use of fall protection when working at heights above 6 feet.
- Employers should implement a job hazard analysis process.
- Employers who learn of physical disabilities which pose a direct threat to an employee's safety should perform threat assessments to evaluate his/her ability to safely perform assigned job duties.

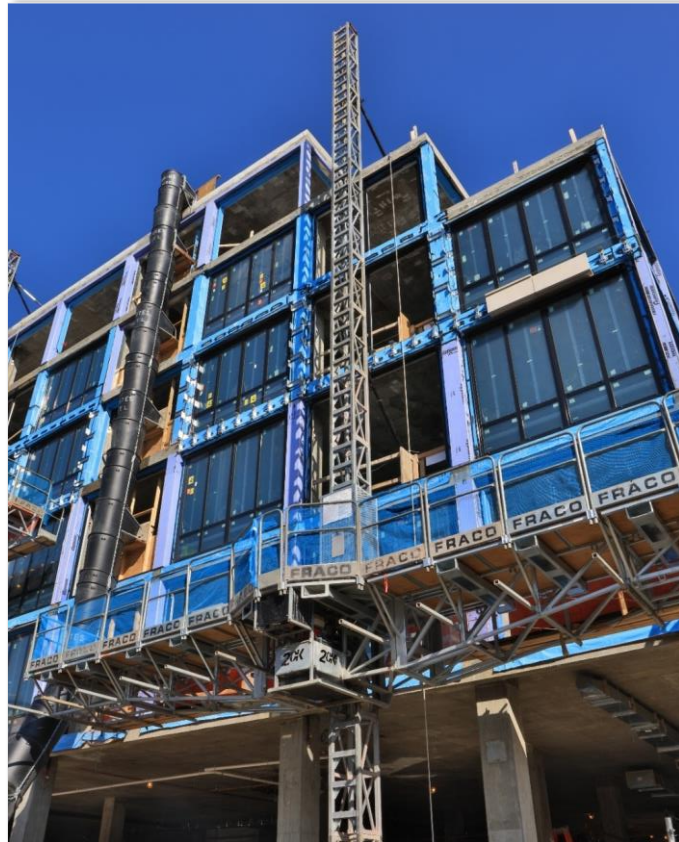
What is a Mast Climbing Work Platform (mast climber)?

- Powered work platform that climbs a vertical tower (mast)
- Varying platform configurations and sizes
- Can be freestanding or fixed to an adjacent structure
- Becoming more popular in the U.S. as a way of replacing traditional scaffolding

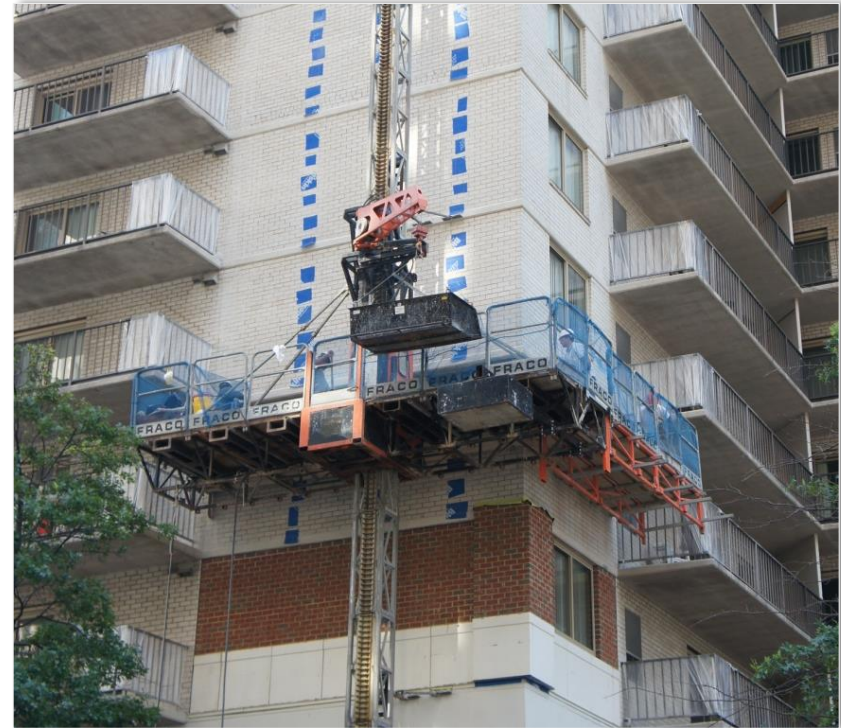
Photo: Bryan Wimer

- Up to 15,000 mast climber units total being used daily (U.S.)
- Approximately 50,000 workers on them daily
- Estimated dis- and re-assembly 4-5 times per year

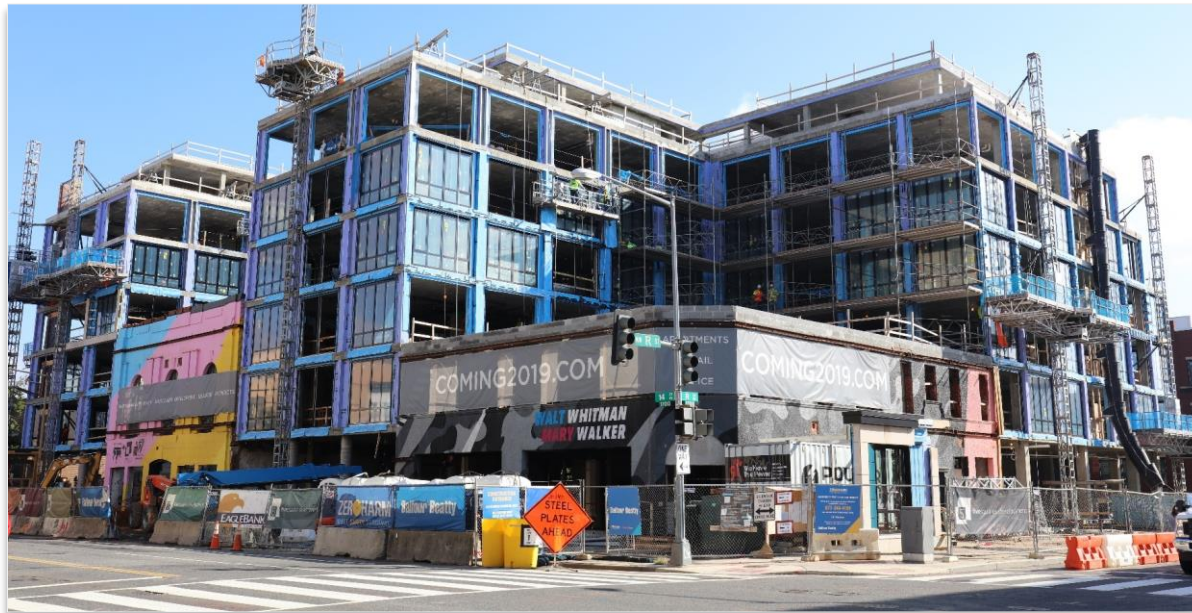
Photos: Bryan Wimer

Mast Climbing Work Platforms require a daily inspection

- “Ground” up
- Manufacturer-specific inspection
- Site visit completed in Sept. 2018

FRM-20K User's Guide FRACO

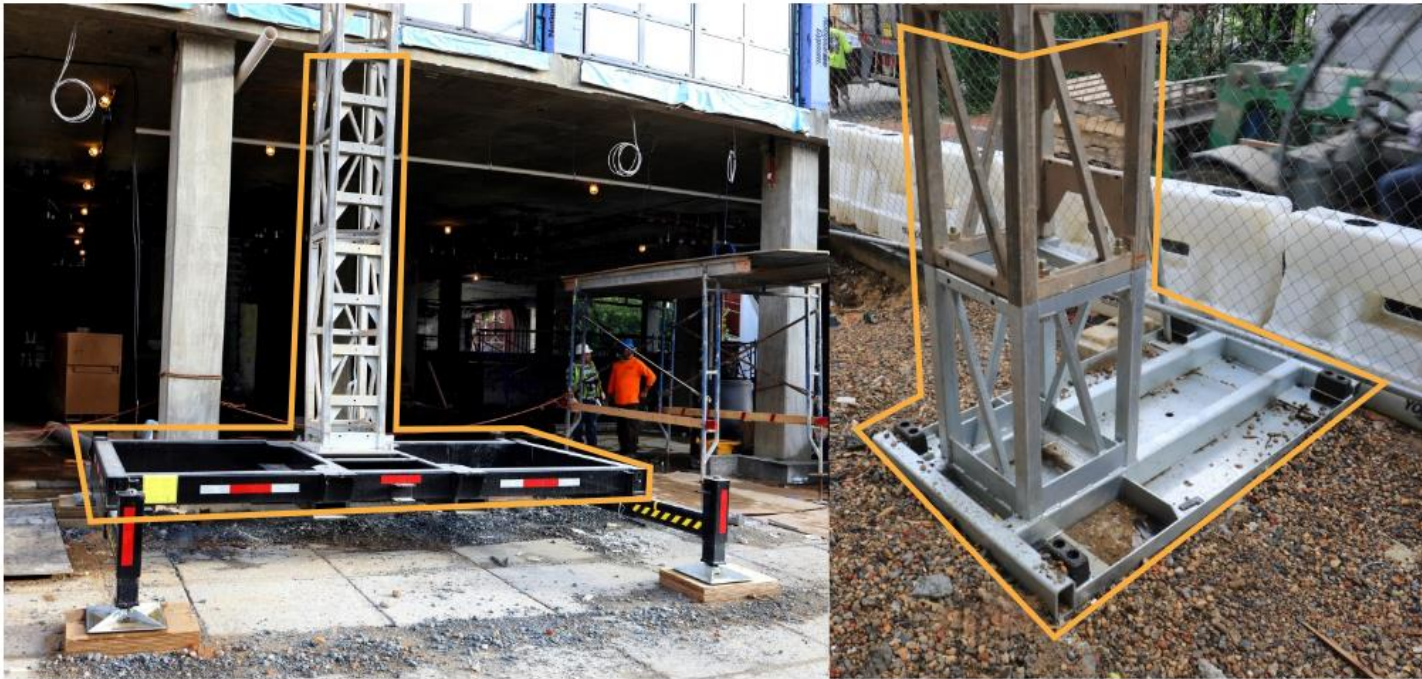
MCWP Daily Inspection Walkthrough

Check the horizontal level of the base, as well as the vertical level (both front and side directions) of the mast structure.

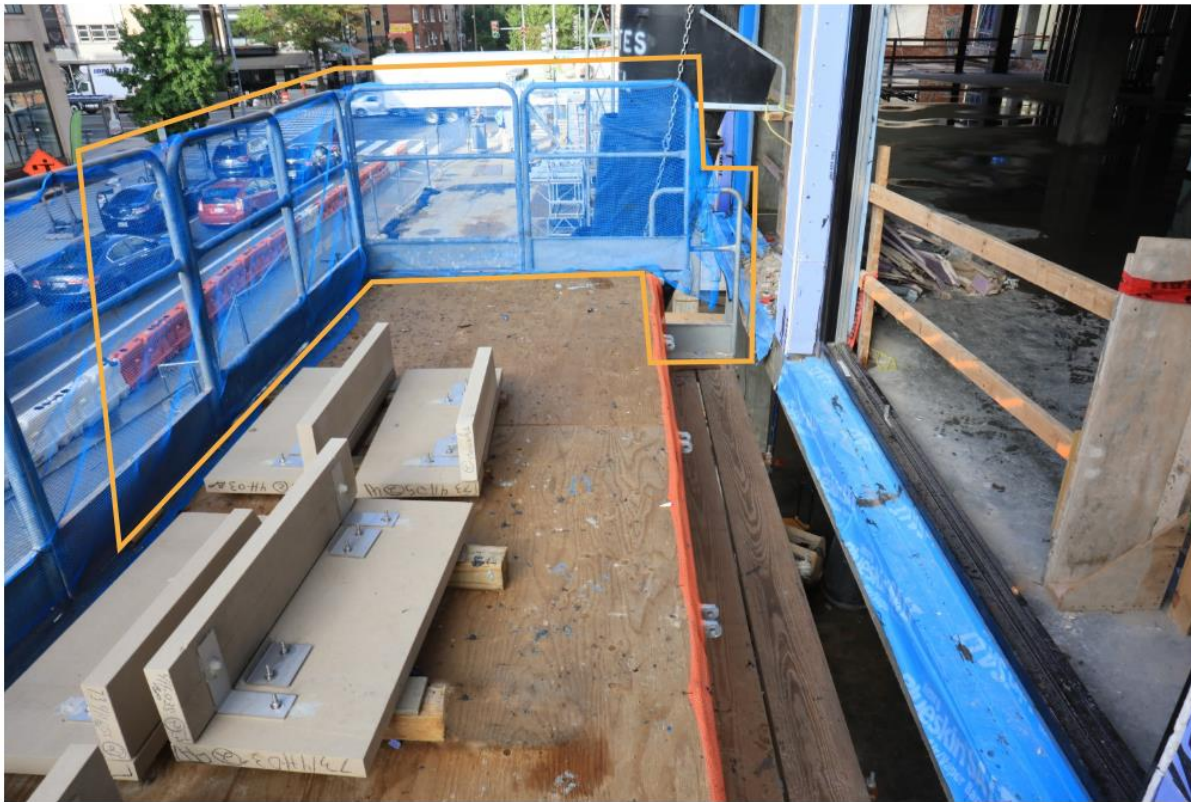
MCWP Daily Inspection Walkthrough

Check that guardrail and end plank guardrail sections are in place and secured and that protective mesh is in place to stop debris from falling and that each meet the requirements set in OSHA 1926.451(g) and 1926.541(h).
