Investigating Fall Fatalities and Injury Claims on Prevention Efforts

Characteristics of Workers and Employers Involved in Severe Construction Falls

Does Experiencing an Injury Claim Impact Small Construction Company Leaders' Participation in a Fall Protection Survey?

Fatal Construction Falls in Michigan: Tracking and Outreach for Prevention

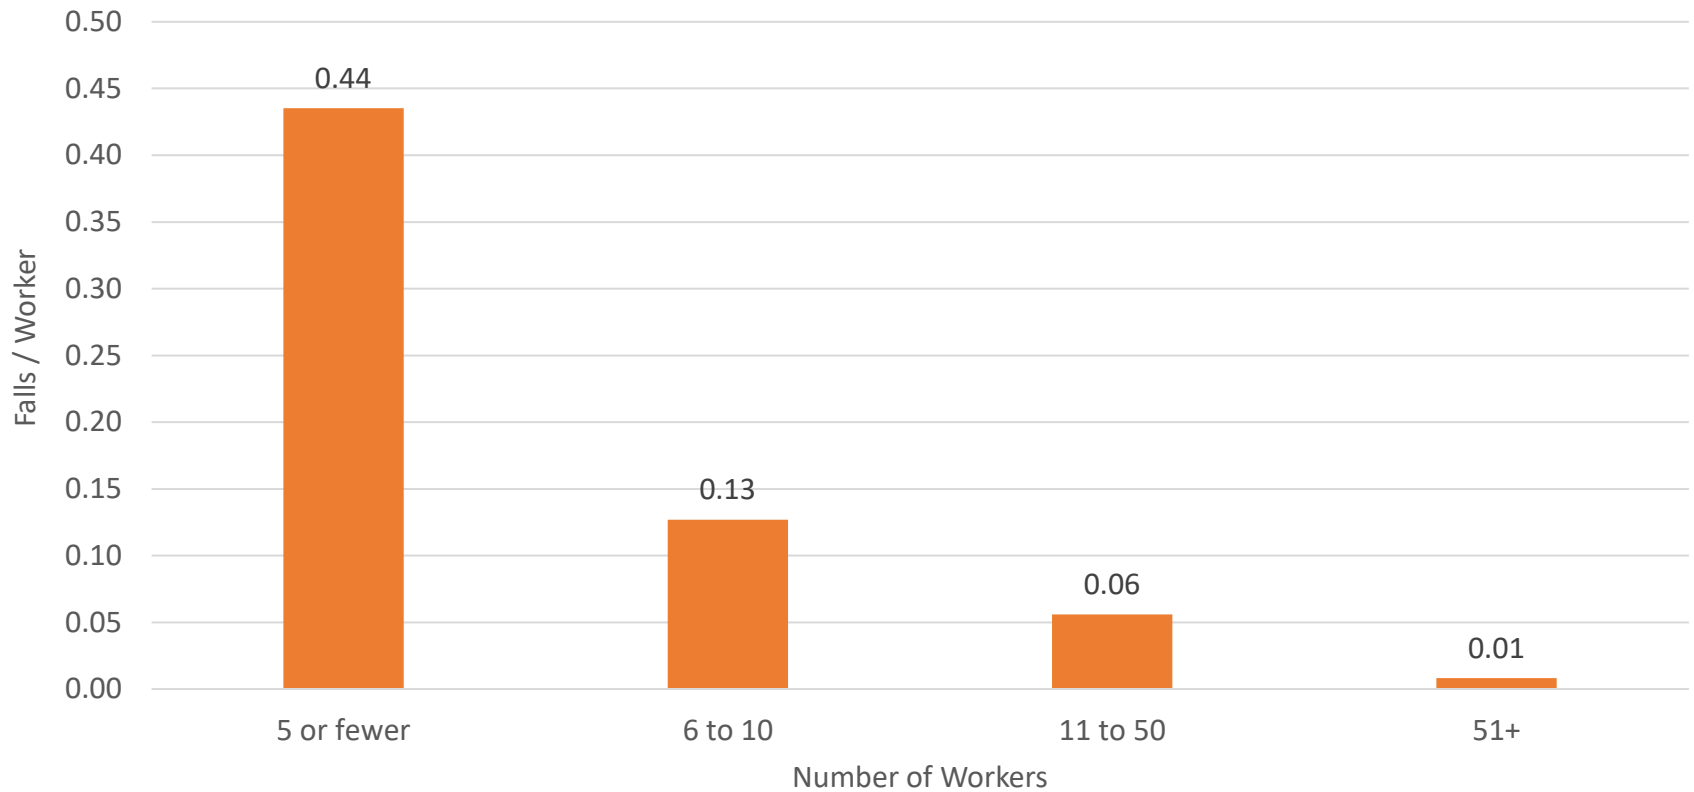
Falls / Worker

WA WC claims data, 2015-2019

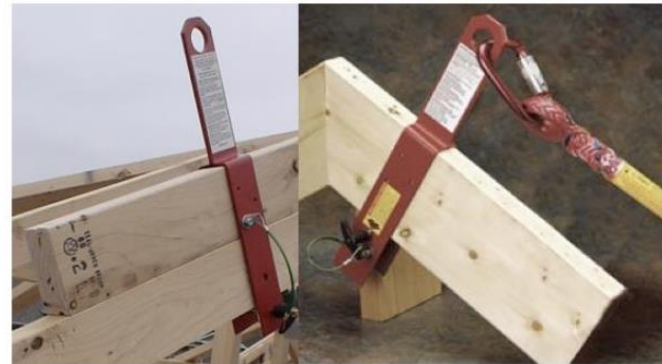
- 22) This is a picture of a Truss Anchor. This anchor is used with a harness and lanyard during sheathing and truss installation. Please note your familiarity with this type of anchor.
- a) Have used often at work
 - b) Have used several times
 - c) Have seen it but never used it
 - d) Never seen it before

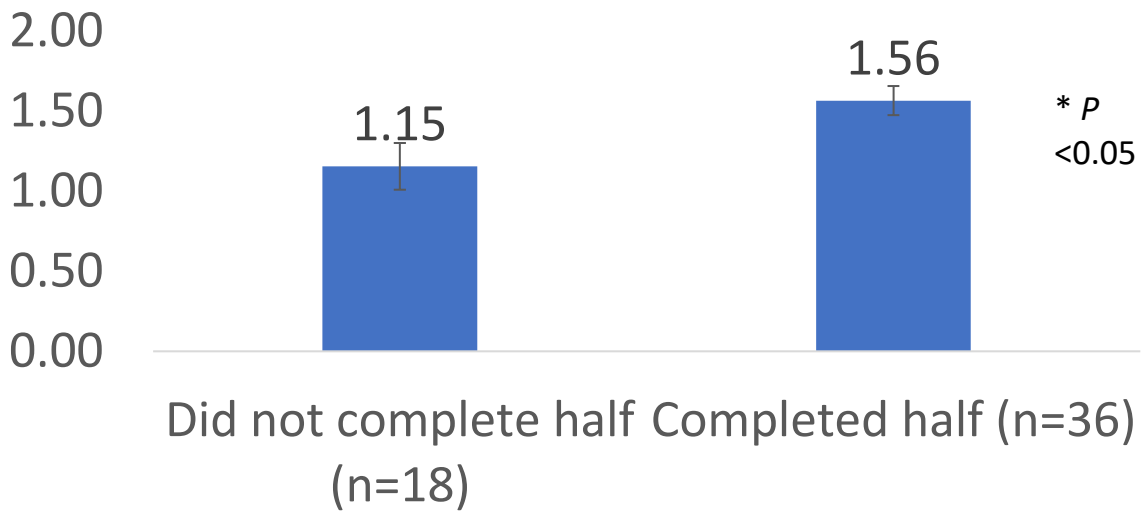
Results: Equipment familiarity by survey engagement

M= 1.42, where 1= "Seen it but never used it" and 2= "Used several times at work"

Anchors, choker strap, rope grabs all significantly higher, $p < .05$

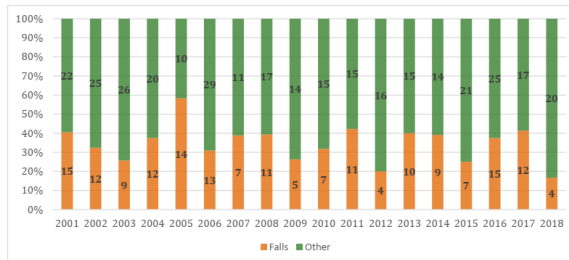
Figure 6. Fatal Falls as Percent of Total Construction Deaths by Year, 2001-2018

Both the number of fatal falls in Construction, and the proportion of all Construction fatalities comprised of fatal falls, reached or matched their lowest levels since 2001. Between 2001 and 2018, the number of fatal falls in Construction ranged from a low of four falls in 2012 and 2018 to a high of 15 falls in 2001 and 2016. The percentage of fatalities in Construction secondary to a fall ranged from 16.7% in 2018 to 58.3% in 2005.
